Municipal Building Conditions Assessment Report

Town of Southwick

Southwick, Massachusetts

August 2018

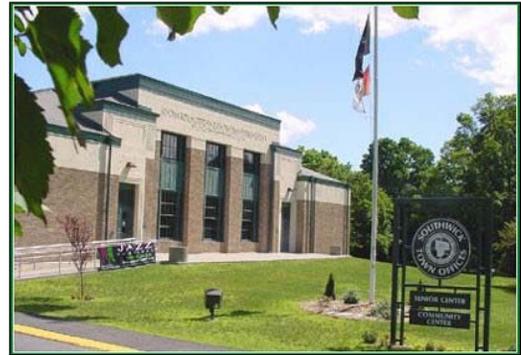
2.1 Town Hall

The Town Hall was originally constructed in 1928 as Southwick High School, with an Art Deco design aesthetic. The building was substantially renovated in 1996 for the Town Offices, (approx. 12,820 SF) and later, in 2012 to accommodate the Council on Aging Senior Center (Approx. 1,800 SF). The building has 3-levels including basement, and approximately 41,820 SF total area. The construction is generally solid masonry with brick veneer. The newer addition(s) are cavity wall construction with brick veneer and concrete masonry unit (CMU) back-up. The 1996 Renovations altered the low slope roof typically associated with a structure of this size and incorporated a steep-slope roof using a combination of wood trusses and stick-framing, finished with asphalt shingle roofing. The completed renovation upgraded the entire interior, creating a new basement storage room under the auditorium floor area, provided accessible toilet rooms and elevator, and outfitted all floors with department offices to serve their needs. The building exterior masonry envelope was restored, and new entrances and fenestration installed, meeting energy code compliance for that time. In general, the building is in good condition.

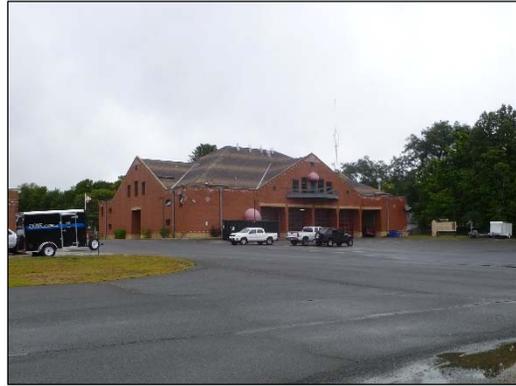
2.2 Fire Station

The Southwick Fire Station is a 2-story rectangular structure of approximately 28,300 SF. The building was constructed in 1999 with an eclectic design aesthetic, reminiscent of "Romanesque Revival". The building is comprised of a simple rectangular form with a large hipped roof, and articulated with four, 2-story dormers with gabled masonry walls. The building is decorated using polychromatic brick and roofing shingles. The building plan has a bi-axial configuration with five apparatus bays occupying the center with flanking side bays containing support functions and office space. The second floor houses the administrative offices, work room, conference room, training room, staff locker rooms and sleeping quarters, day room, and kitchen. The conference room is adorned with an elliptical aluminum window. The kitchen/dining space has access to an exterior porch.

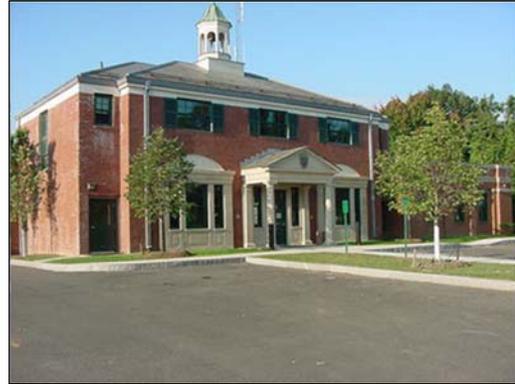
2.3 Police Station

The Police Station was originally built in the 1940's as the Town's primary municipal building, housing the Town Offices along with the Fire and Police Stations. The building was designed in the "Colonial Revival" style. Between 1996 and 1999, the Town had renovated a school building to house the Town's Municipal Offices and constructed a new facility for the Fire Department. In 2000, this building was substantially renovated, and dedicated to house the Police Department. The building is approximately 13,200 SF.

The Police building comprises two distinct structures, one 2-story building housing the administrative offices and second floor conference room, and a one-story addition housing garage bays, storage, sally port, prisoner processing, holding, and patrol officer support. The 2-story structure is solid brick masonry construction, with limestone band coursing, entrance portico, and paneled window bay. The roof of the 2-story building is wood framed with original slate roofing, lead-coated copper flashing, and adorned with the original wood cupola/belfry with copper roof and finial. The 1-story addition is similar solid wall construction with brick and CMU. The roof is low-slope, steel framed with gypsum plank roof deck, as well as corrugated steel deck, and EPDM membrane roofing. The building is generally in good condition.

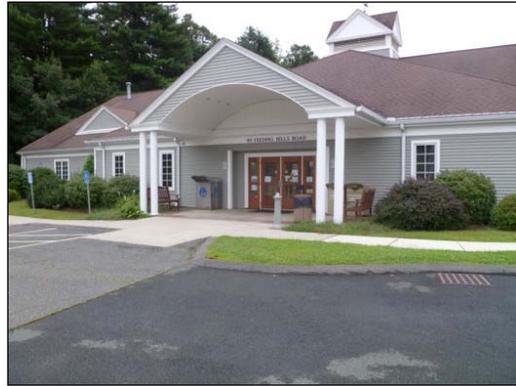
2.4 Public Library

The Southwick Public Library is a 1-story rectangular structure of approximately 13,500 SF. The building was constructed in 1997 with an eclectic design aesthetic, displaying Colonial Revival influences. The building is comprised of a simple rectangular form with a large hipped roof, and articulated with four major dormers, one forming the entrance portico. The building is adorned with a central cupola of similar construction. The building is clad with vinyl clapboard siding with painted aluminum panning making up the fascia, eave, and rake details. The siding has vinyl corner boards, and related trim.

The entrance portico is large with a segmented-arch open ceiling finished with a linear aluminum strip ceiling system and supported by paired columns. The roof has asphalt shingles, with aluminum gutters and downspouts. The building plan has a bi-axial configuration with large reading room, and central book stack area. Children's room occupies one dormer, with the office and support functions the opposite. Windows are vinyl clad wood with exterior muntin grids. Doors consist of a combination of insulated hollow metal service doors, and a monumental mahogany entrance door with side lights. The construction is wood framed walls and wood trusses. The interior is painted gypsum wall board with decorative soffits, and vaulted ceiling. In 2016, the building was renovated to update a dry sprinkler system to a wet sprinkler system for the entire building. The building's boiler and electrical equipment and storage rooms are located in a partial basement with stair access.

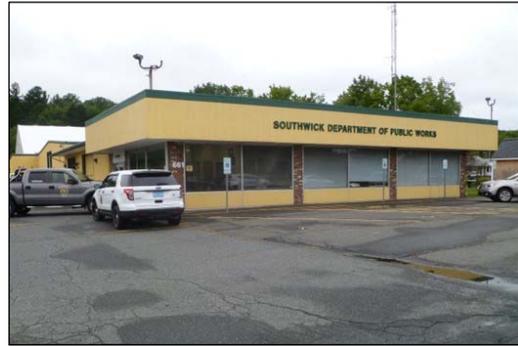
2.5 Department of Public Works

In 2011 the Southwick Department of Public Works was relocated from the Public Safety Complex on Depot Street to the former Suburban Chevrolet building on College Highway. The former Suburban Chevrolet building, built in 1972, was renovated prior to the DPW's relocation in 2011 to accommodate modernized office and support areas for the staff along with accessible toilet rooms. Since then, no upgrades have been made to the facility. The building is a typical pre-engineered metal building system with forward-most showroom and business office. The building is 1-story and approximately 18,000 SF. The existing structure is 47 years old and has reached its useful life.
